# THE BUFFALO CREEK FLOOD AND DISASTER

OFFICIAL REPORT FROM THE GOVERNOR'S  
AD HOC COMMISSION OF INQUIRY

THE BUFFALO CREEK  
FLOOD AND DISASTER

Official Report from the Governor's  
Ad Hoc Commission of Inquiry

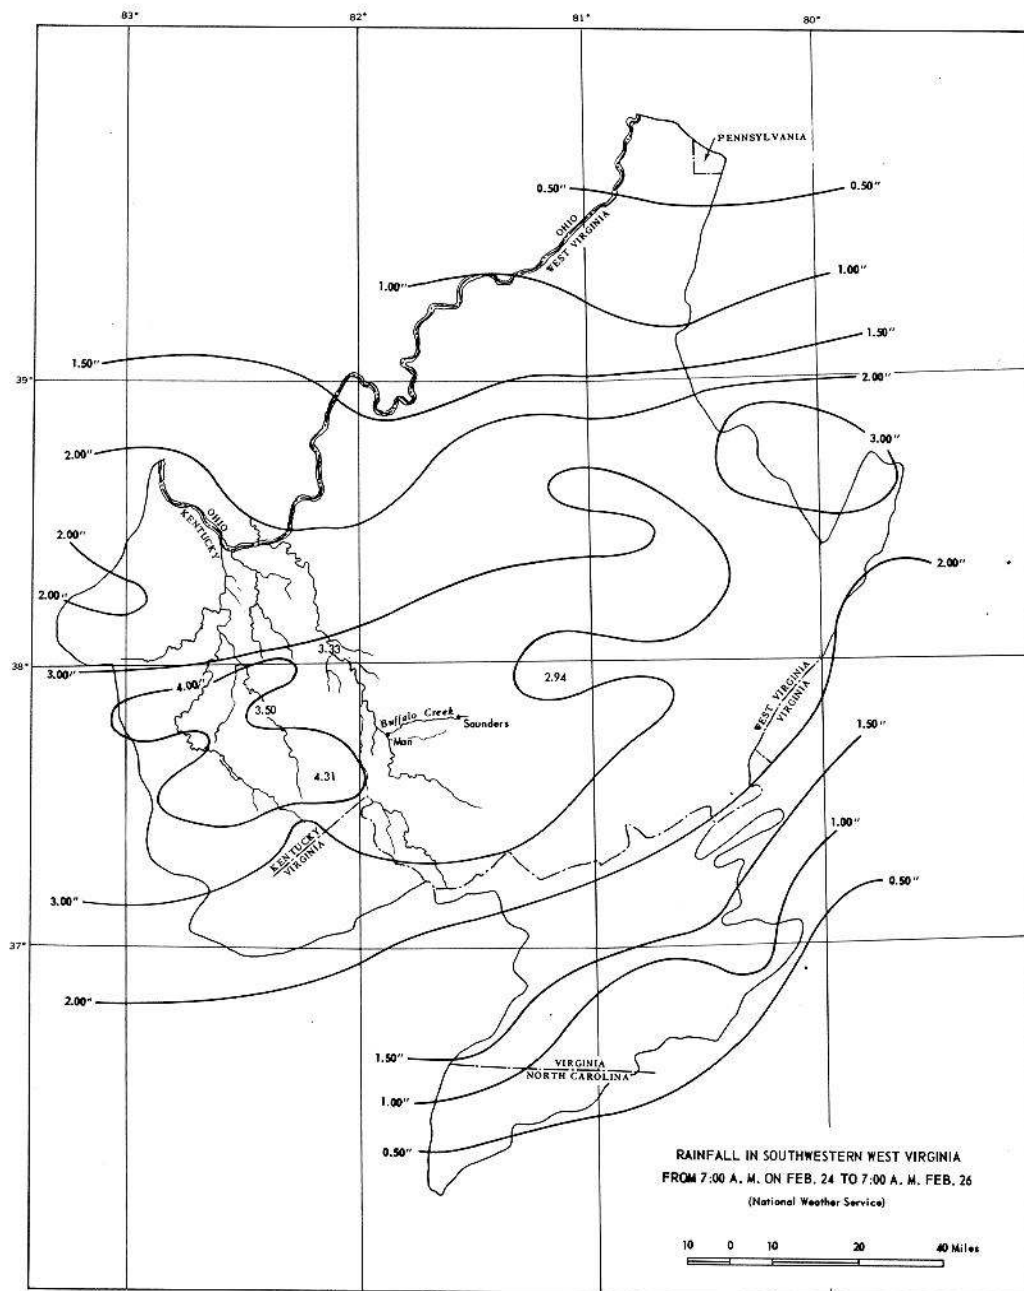
During the 72-hour period immediately preceding the flood, precipitation averaged 3.7 inches at Logan and at other stations 15-20 miles south and east of Buffalo Creek, according to the National Weather Service (Figure 2-6). About half of the rainfall (1.9 in.) at Logan fell in the 24 hours that preceded the flood. Precipitation tapered off to the north during the 3-day period, measuring 2.35 inches in Charleston. Maximum precipitation during the storm was 4.5 inches produced at Williamson, 22 miles west of Buffalo Creek. A bucket survey in the Buffalo Creek hollow conducted by field parties during the week following the flood revealed no catchment of precipitation in open cans and other available containers that exceeded 3.7 inches recorded at Logan.

Figure 2-6 Map showing rainfall in southwestern West Virginia February 24 to February 26, 1972

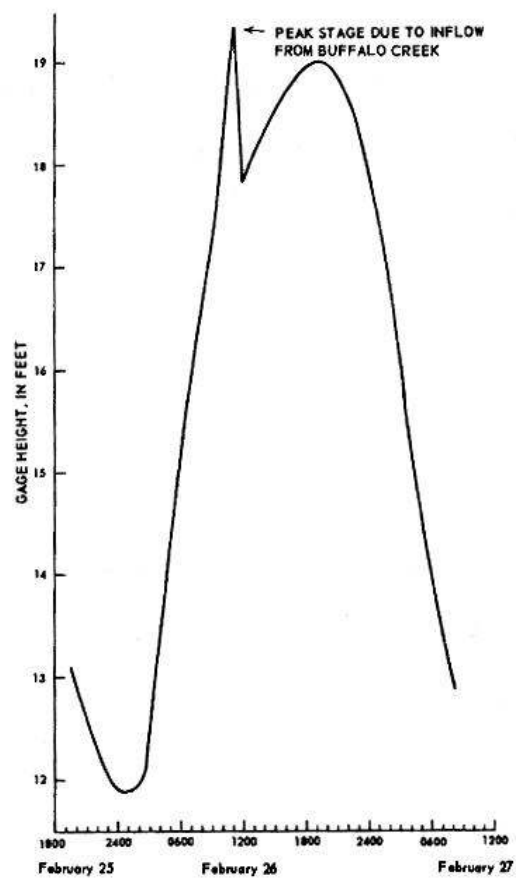
*Figure 2-14* Graph showing the sudden high peak of 19.34 feet produced on the gaging station record for Guyandotte River at Man by the flood inflow from Buffalo Creek.

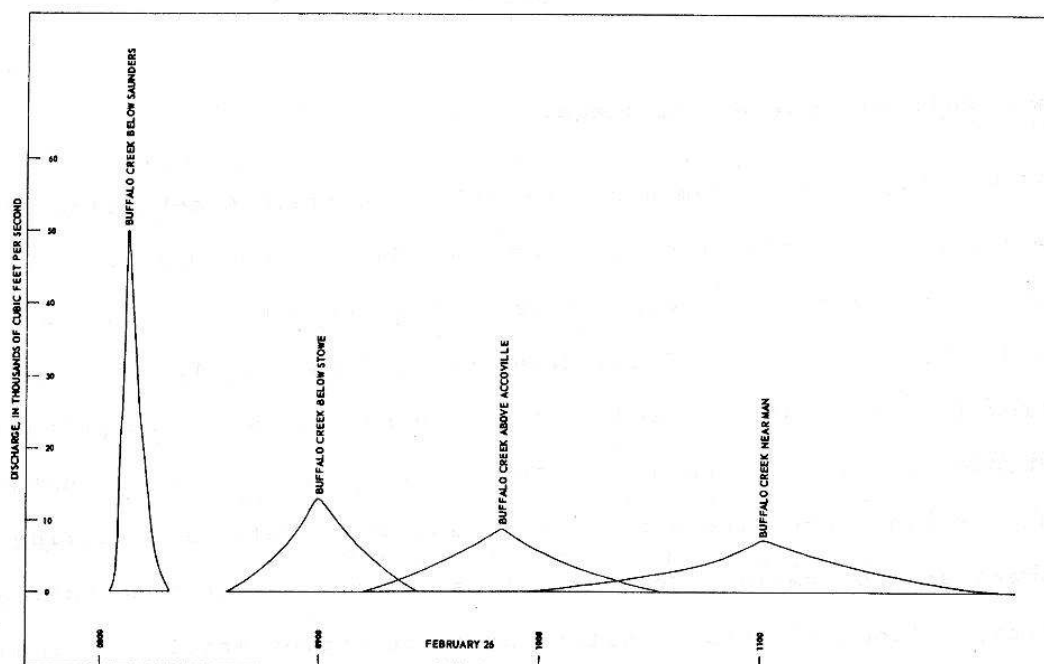
Peak discharges were greatly reduced due to valley storage as the flood wave moved downstream. This effect is shown in Figure 2-15, where flood hydrographs were estimated on the basis of peak flow information obtained at indirect measuring sites and from flow duration information furnished by local residents. Attenuation due to valley storage reduced the peak flow to 13,000 cfs (5.8 million gpm) by the time the flood crest reached Stowe 6 miles downstream from the mouth of middle Fork; although the total discharge past Stowe was slightly greater than the total flow past Saunders, the floodflow took more than three times longer to travel past Stowe. The same attenuating effect from valley storage stretched out the floodflow all the way down Buffalo Creek; the floodflow that

Figure 2-15 Estimated flood hydrographs for Buffalo Creel below Saunders, below Stowe, above Accoville, and near Man on February 26, 1972

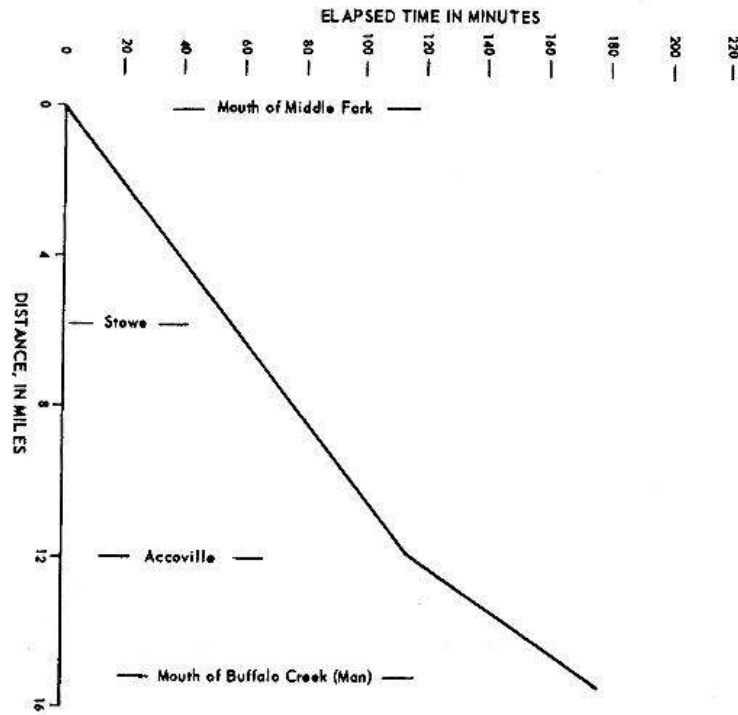
Estimates of time of travel of the flood peak were made based on information furnished by local residents. The flood wave passed through the Buffalo Creek valley in almost exactly 3 hours, reaching the mouth of Buffalo Creek at Man at 11:00 a.m. on February 26. The traveltime versus distance relation for the flood wave is shown in Figure 2-16.

Mean velocities are estimated at 20 feet per second from Saunders to Pardee, 15-20 feet per second below Pardee to Lorado, and diminishing to about 10 feet per second near Accoville and to 5 feet per second or less near Man.

Figure 2-16 Graph showing time of travel of the flood wave down Buffalo Creek

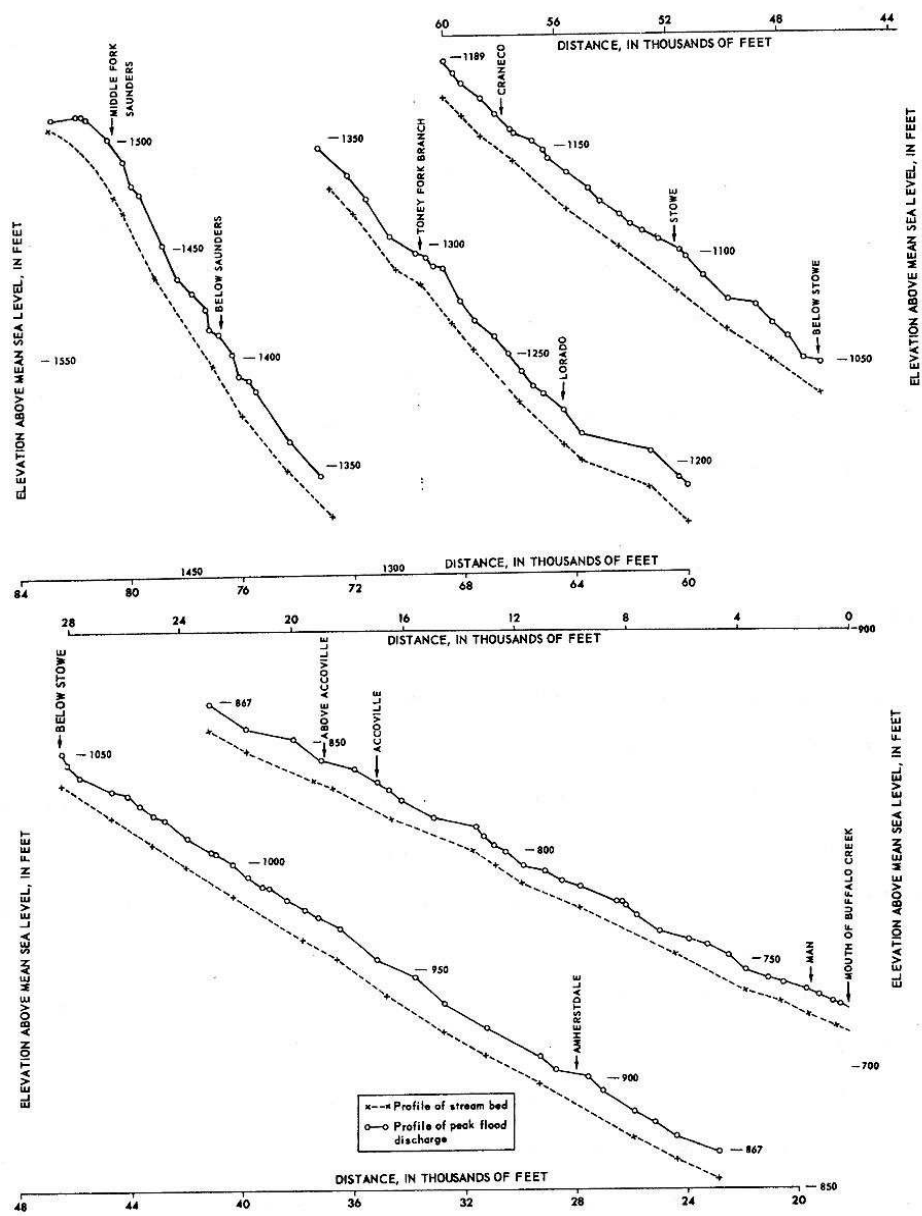
Profiles of the flood wave and of the streambed were obtained for the 17-mile reach of Buffalo Creek from the mouth of middle Fork to Man, from a survey of high-water marks at many sites throughout the reach (Figure 2-17). The fall, or total drop in elevation, from Saunders to Man is approximately 750 feet. The slope of the flood profile ranges from an average of 96 feet per mile in the reach from Saunders to Pardee to 33 feet per mile in the reach from Accoville to Man.

The depth of flow in the stream channel at points along Buffalo Creek can be estimated from Figure 2-17 by subtracting the bed elevation from the flood profile. The flood plain of Buffalo Creek ranges from 200 to 500 feet wide throughout the reach from Saunders to Man. Ground elevations on this flood plain can be determined by surveying to selected points on the flood plain from nearby bench marks. The depth of flooding on the flood plain can then be estimated by subtracting the ground elevation from the flood profile shown in Figure 2-17. At the time of the peak, the depth of flow on the flood plain was approximately 12-10 feet deep from Saunders to Lorado, 9-6 feet deep from Craneco to Latrobe, and 5-2 feet deep from Robinette to Kistler.

Figure 2-17 Profile of the peak flood discharge and of the streambed, Buffalo Creek, Middle Fork to Man
